## Component Video/Analog Audio Wall Balun 500053-WP-US

### Quick Installation Guide

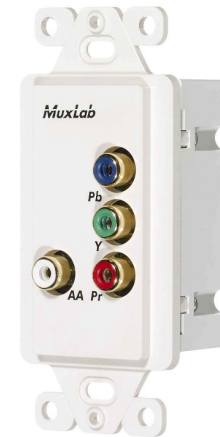
1. Identify the pin configuration of the baluns. Three (3) twisted pairs are required for video and one (1) twisted pair is required for optional analog audio. The pin configuration follows the EIA/TIA 568A/B standard. The Component Video/Analog Audio Balun is reverse polarity sensitive. Please ensure that wiring is straight-through (Ring to Ring, Tip to Tip).
